DITCH EROSION BALES

SHEET EC1 OF 4

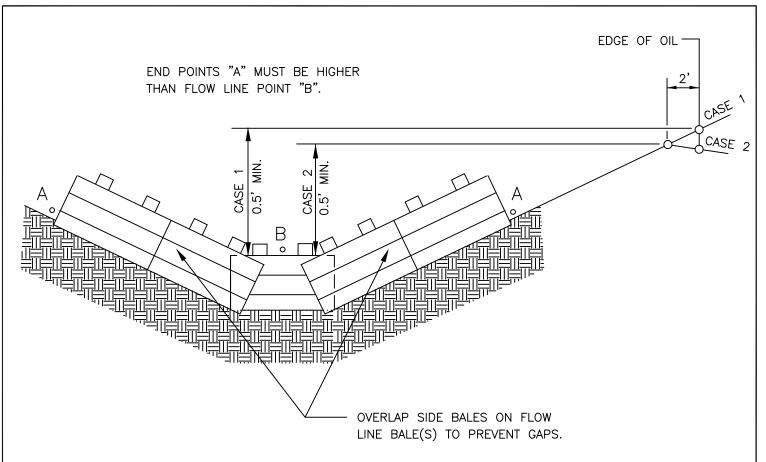
DITCH EROSION BALES
CROSS—SECTION LOCATIONS

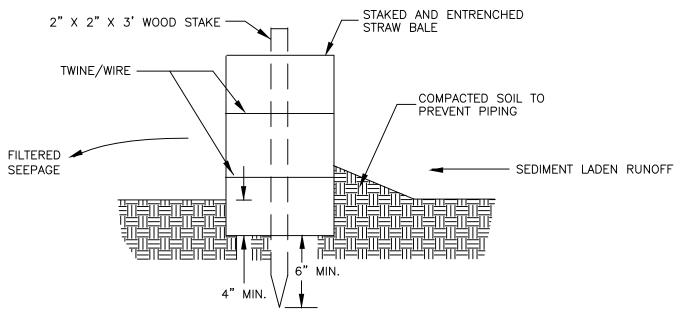
CROSS SECTION OF A PROPERLY INSTALLED STRAW BALE
